**SERVICE  
BULLETIN**

**MANDATORY SERVICE BULLETIN Z 242L/19a - Rev.3, Z 143L/20a**  
**Supersedes Mandatory Service Bulletin Z 242L/19a - Rev.2**

Correction 4.1:  
All Zlin 242L aircraft up to S/N 0730 incl.  
All Zlin 143L aircraft up to S/N 0029 incl., except  
S/N 0025 and 0027.  
Correction 4.2:  
All Zlin 242L aircraft up to S/N 0733 incl.
3. **SUBJECT: Z 242L aircraft:** Freezing-up of the main engine vent line and safety rubber cup in the secondary engine vent line can occur at low ambient air temperature. This can result in forcing-out of the front crankcase seal ring and oil leakage from the engine.

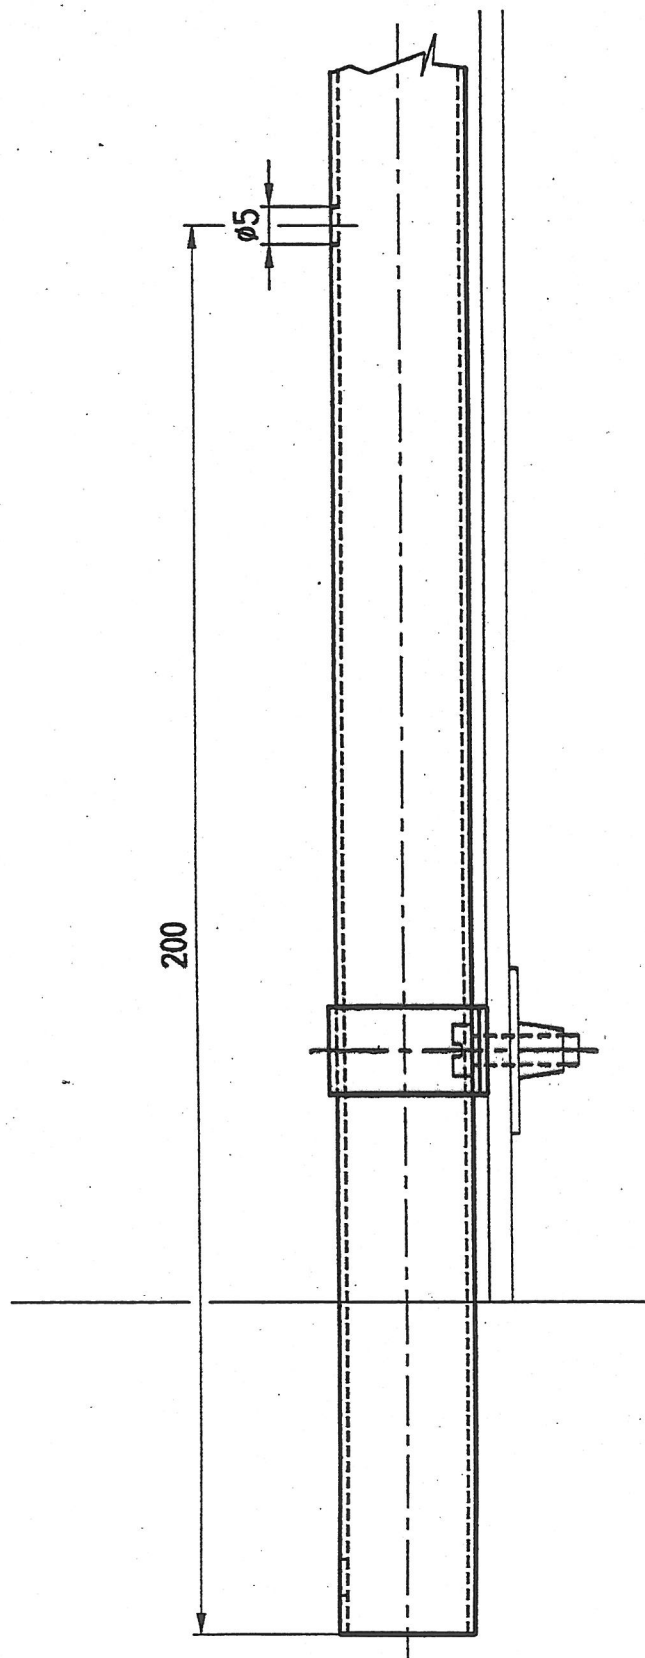
Fig. 2

**Z 143L aircraft:** Freezing-up of the end of the engine vent tube can occur at low ambient temperature. This can result in forcing-out of the front crankcase seal ring and oil leakage from the engine.
4. **CORRECTION:**
  - 4.1 Engine vent adaptation of the Z 242L and Z 143L aircraft.
  - 4.2 Corresponding revision of the Maintenance Manual of the Z 242L aircraft - Vol. I.  
Corresponding revision of the Flight Manual was issued by the Mandatory Service Bulletin  
Z 242L/19a - Rev. 2 remains effective.
5. **TIME OF COMPLIANCE:**

Dismantle the vent tube, drill the hole in accordance with Fig. 2, install the tube back - position of the hole in accordance with Fig. 2.
