**MANDATORY SERVICE BULLETIN Z 242L/20a**

1. MODELS AFFECTED: ZLIN Z 242L aircraft S/N 0657 and up if they are provided with Maintenance Manual Vol.I. and Vol.II. with Doc.No. 003.022 and 003.032.

2. SUBJECT: Change of airworthiness limitation.
3. CORRECTION:
  - a) Change of Section 5.4. "Possible Failures of Main Wing Spar and Their Remedies (Structural Inspection)" and change of Chapter 9. "Airworthiness limitation" in Maintenance Manual of Z 242L Aircraft, Vol. I.

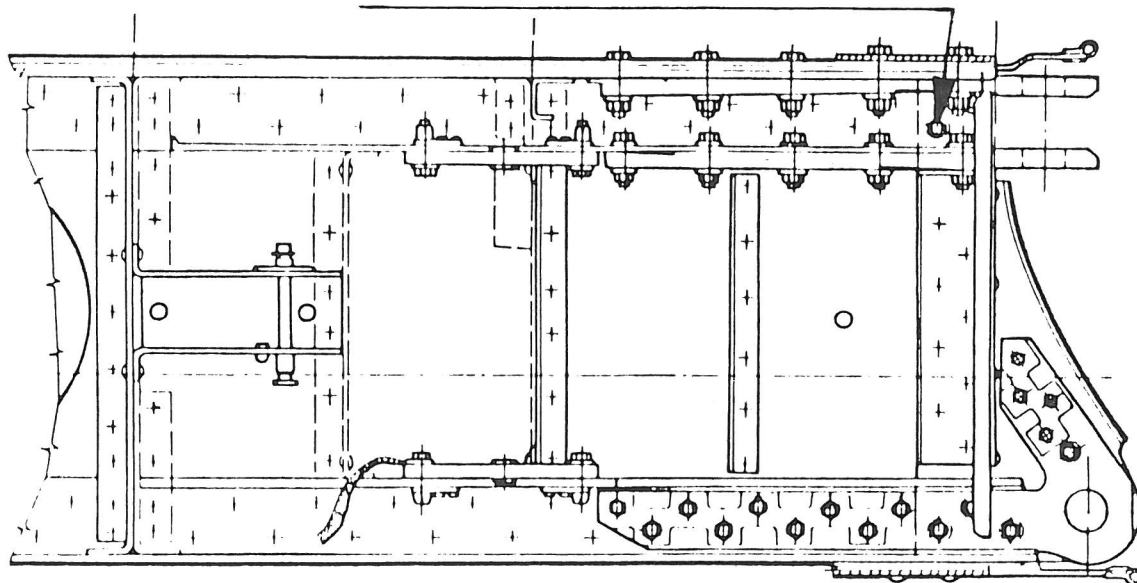
Rivet replaced with fitted bolt

Fig.: Replacement of 5 DuK 4x15P rivet (ČSN 02 2302.5) with M 5x20 ONL 3120.24 fitted bolt

5. Using hand electrical drilling machine with angular extension piece for spindle deflection by 90° drill out the rivet supporting head (see Fig.) and a part of its shank (to the depth of about 1/3 of the overall material thickness gripped) with a drill  $\phi$  4.1 and overall length of 65 mm). Drive out the remaining part of the rivet with a suitable driving-out mandrel.
6. Re-drill the holes remained after the removed light-alloy rivets with hand el. drilling machine having an angular extension piece on it. Use a drill  $\phi$  4.8 and with overall length of 65 mm. When drilling the drilling machine must be in perpendicular position to flange area!!!

7. Ream the re-drilled holes with hand reamer  $\phi$  5H7 and ratchet wrench.
8. Remove chips that result from drilling and reaming.
9. Check the reamed holes with plug gauge.
10. Mount bolt M 5x20 ONL 3120.24 with washers 5.3 CSN 02 1702.14 placed under the bolt head and under the nut M5 ONL 3247, into the cleaned, reamed hole.
