ZLIN AIRCRAFT a.s.

MANDATORY BULLETIN Z 242L/29a, Z 143L/16a

Occurrence of the checking block L 143.8521 damage

in operation.

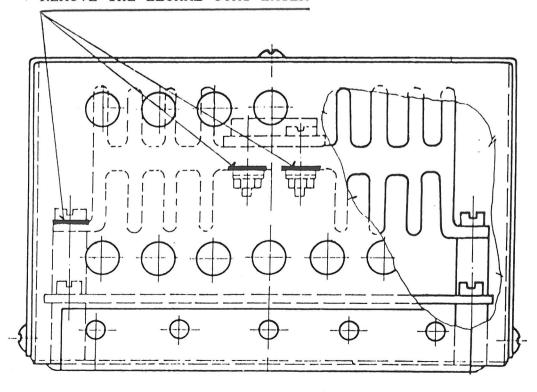
Fig.: Checking block L 143.8521

REMOVE THE ELOXAL COAT LAYER

9.3 Removal of the failure cause:
Remove the eloxal coat layer of the cooler under attachment nuts of all three KD 503 transistors (or their equivalents) and under the screw of the supply voltage lead to the cooler. After cleaning off and tightening, re-paint these joints with the protective lacquer.
