**SERVICE  
BULLETIN**

MANDATORY SERVICE BULLETIN Z 126, Z 226/32a - Rev.1  
Z 326/86a - Rev.1  
Z 526/69a - Rev.1  
Z 726/19a - Rev.1

1. DATE: April 25, 1998
2. MODELS AFFECTED: All Z 126, Z 226B, Z 226T, Z 326, Z 326A,  
Z 526, Z 526A, Z 526AS, Z 526F, Z 526L,  
Z 526AFS, Z 726 and Z 726K aircraft.
3. SUBJECT: Sporadic occurrence of corrosion on the main  
wing spar flange plates.
4. CORRECTION: Visually check the wings in area of the main  
spar.  
The wings attacked from corrosion must be put  
out of operation.
5. TIME OF COMPLIANCE: a) Before next flight.  
b) Before first take-off of airplane with  
wings in which this bulletin was not  
accomplished.

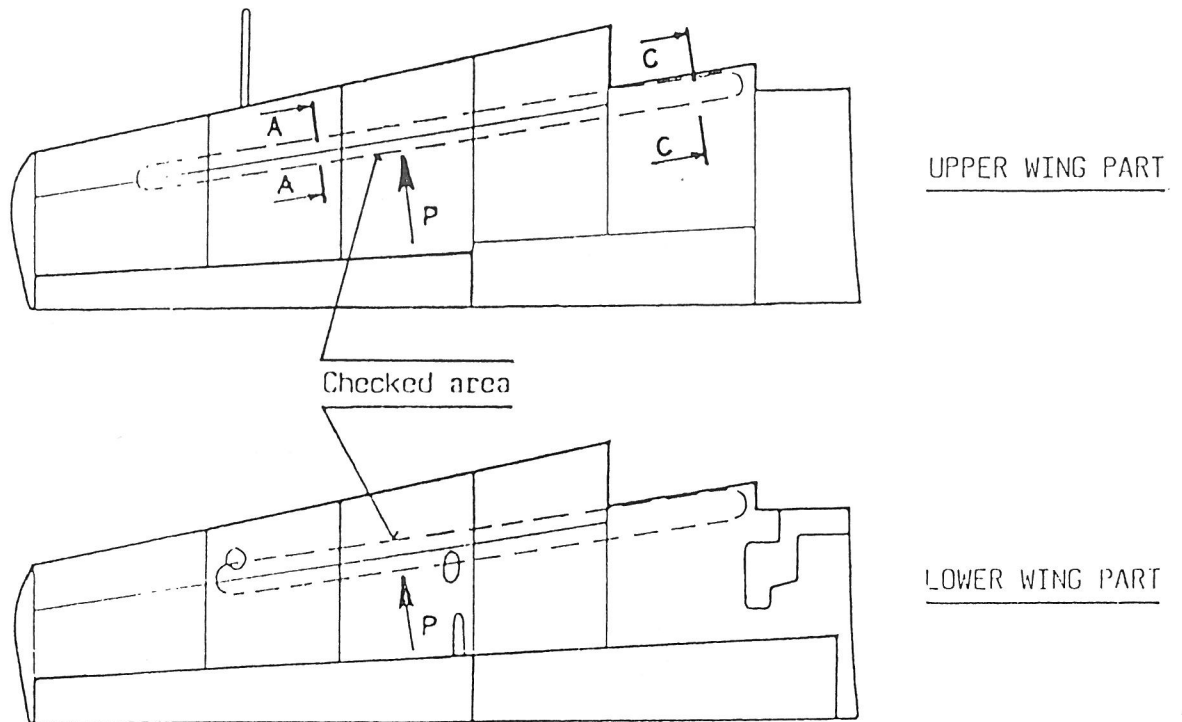
- a) Check surface of the upper and the lower wing part in the main spar area:

Local corrosion occurred on the outside of angle, that creates the wing spar flange plate (see Section A-A), is reliably detectable at view in direction "P" (see Figure of Wings) because the exfoliation corrosion occurrence is shown by the skin sheet concavity on the rivet row (see Section B-B) that is caused by the attacked area swelling. Also there may be the rivet heads loosened considerably in attacked area.
