**MANDATORY SERVICE BULLETIN Z 50/42a AND Z 50M/14a**

1. **DATE:** May 25, 1998
2. **MODELS AFFECTED:** All Z 50L, Z 50LA, Z 50LE, Z 50LS, Z 50LX and Z 50M aircraft.
3. **SUBJECT:** Occurrence of damage of riveted joint of the foot control cable suspensions at the rudder.

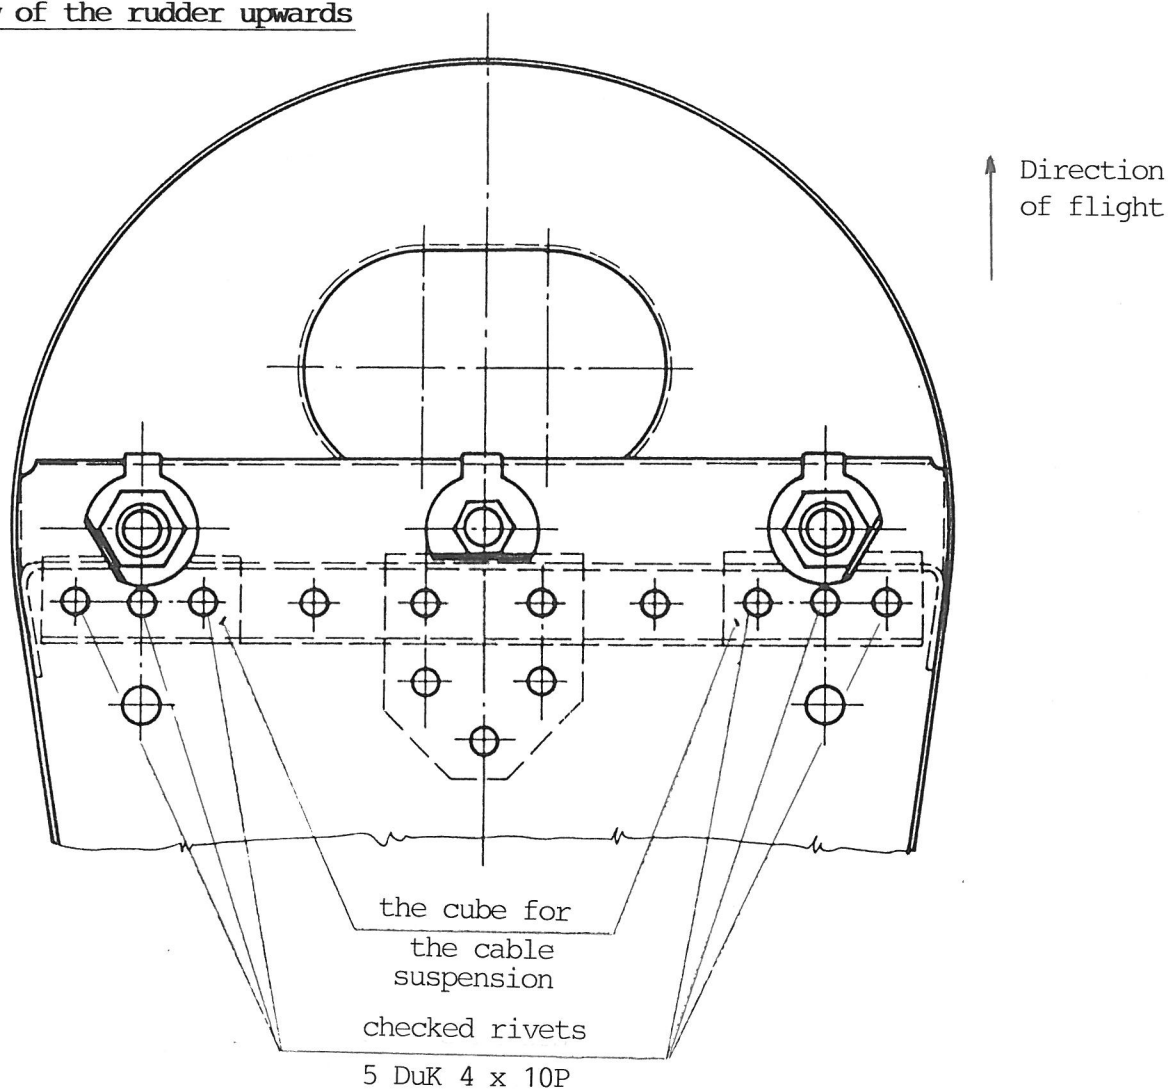
Fig. 1: View of the rudder upwards

a) damage (loosening or cutting-off) of the rivets by means of which the cubbes for the cable suspensions of the foot control are fastened (Fig. 1);

Either loosened or cut off rivets according to the point a) or undue diameter according to the point b) are inadmissible. If you find out the damage according to the point a) or using the undue rivet diameter according to the point b) accomplish working procedure described in the Service Instruction No. 5 (Enclosure 2 of this bulletin).
