MANDATORY SERVICE BULLETIN Z 50/42a AND Z 50M/14a

1. **DATE:** May 25, 1998
2. **MODELS AFFECTED:** All Z 50L, Z 50LA, Z 50LE, Z 50LS, Z 50LX and Z 50M aircraft.
3. **SUBJECT:** Occurrence of damage of riveted joint of the foot control cable suspensions at the rudder.

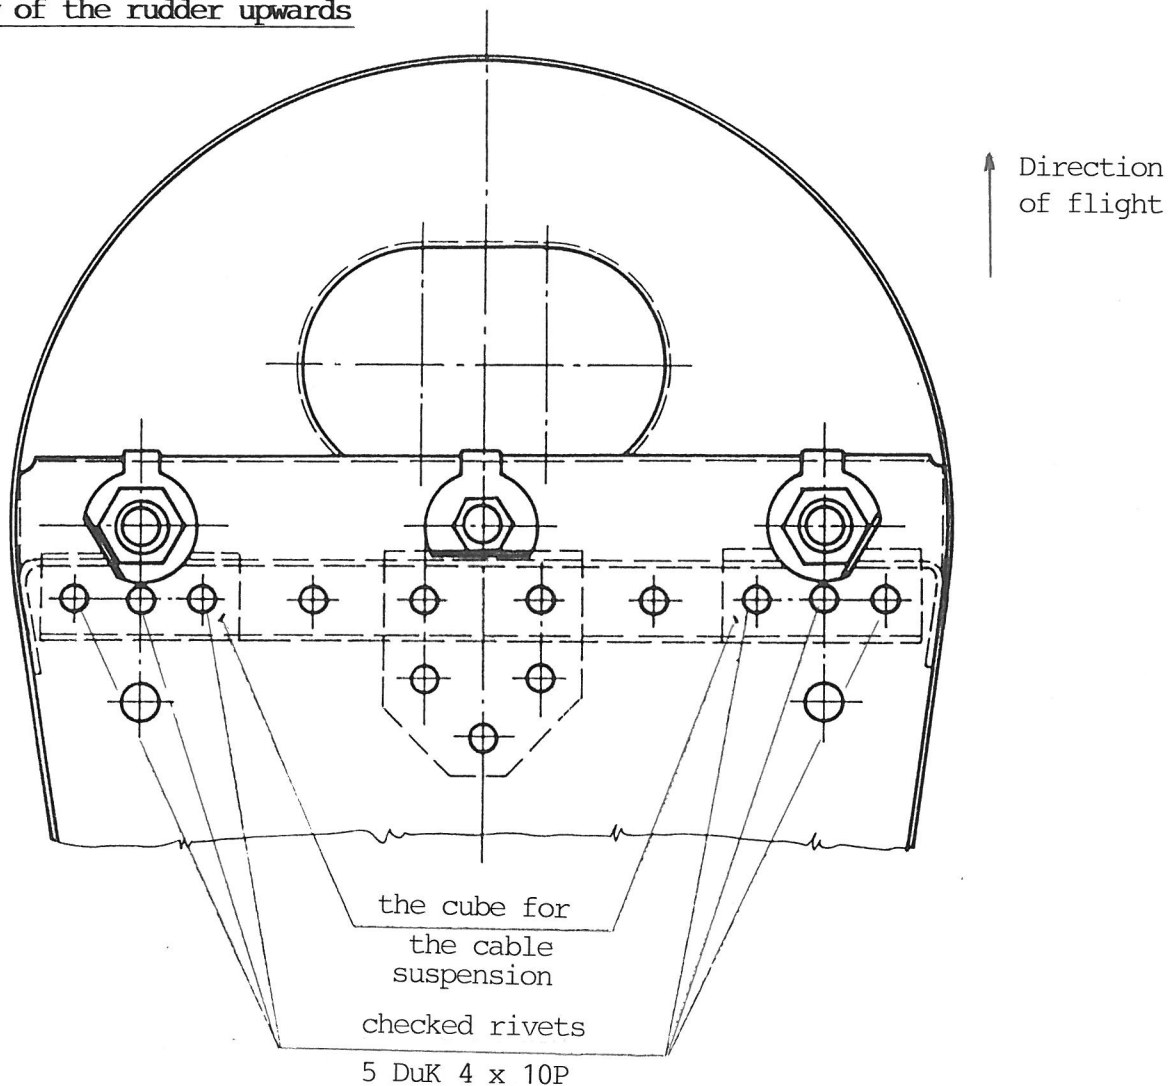
Fig. 1: View of the rudder upwards

a) damage (loosening or cutting-off) of the rivets by means of which the cubbes for the cable suspensions of the foot control are fastened (Fig. 1);

Either loosened or cut off rivets according to the point a) or undue diameter according to the point b) are inadmissible. If you find out the damage according to the point a) or using the undue rivet diameter according to the point b) accomplish working procedure described in the Service Instruction No. 5 (Enclosure 2 of this bulletin).
