**SERVICE
BULLETIN**

MANDATORY SERVICE BULLETIN Z 126, Z 226/32a - Rev.1
Z 326/86a - Rev.1
Z 526/69a - Rev.1
Z 726/19a - Rev.1

1. DATE: April 25, 1998
2. MODELS AFFECTED: All Z 126, Z 226B, Z 226T, Z 326, Z 326A,
Z 526, Z 526A, Z 526AS, Z 526F, Z 526L,
Z 526AFS, Z 726 and Z 726K aircraft.
3. SUBJECT: Sporadic occurrence of corrosion on the main
wing spar flange plates.
4. CORRECTION: Visually check the wings in area of the main
spar.
The wings attacked from corrosion must be put
out of operation.
5. TIME OF COMPLIANCE: a) Before next flight.
b) Before first take-off of airplane with
wings in which this bulletin was not
accomplished.

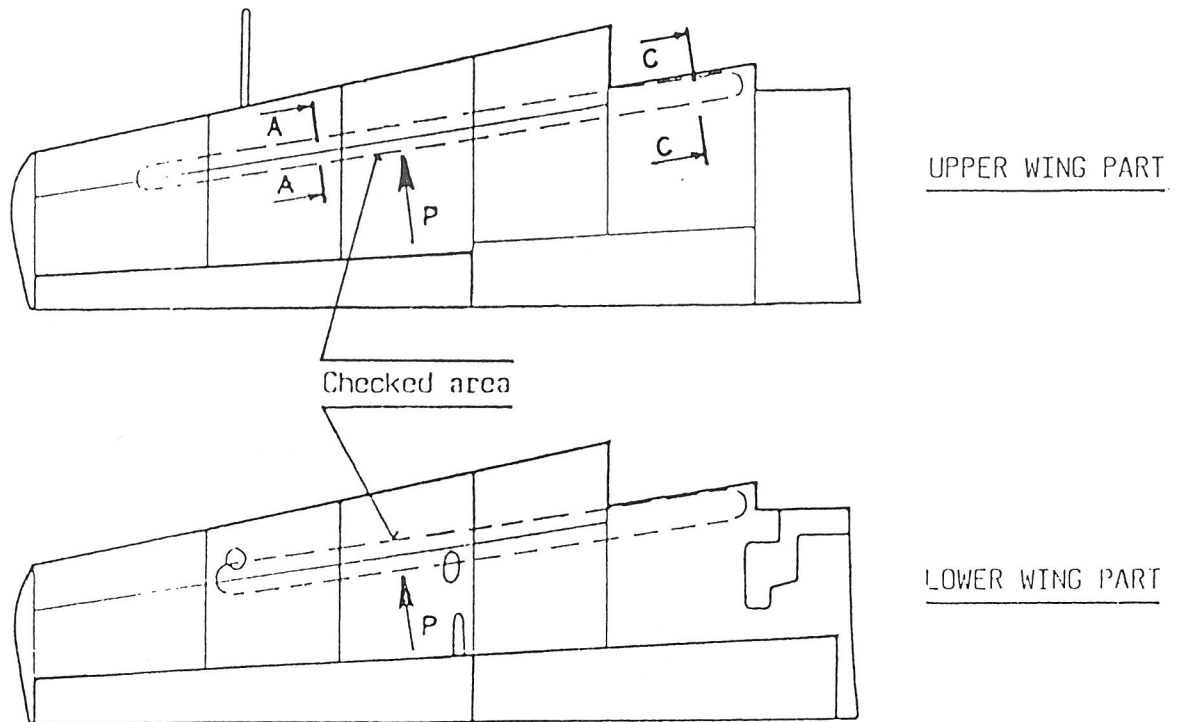
- a) Check surface of the upper and the lower wing part in the main spar area:

Local corrosion occurred on the outside of angle, that creates the wing spar flange plate (see Section A-A), is reliably detectable at view in direction "P" (see Figure of Wings) because the exfoliation corrosion occurrence is shown by the skin sheet concavity on the rivet row (see Section B-B) that is caused by the attacked area swelling. Also there may be the rivet heads loosened considerably in attacked area.

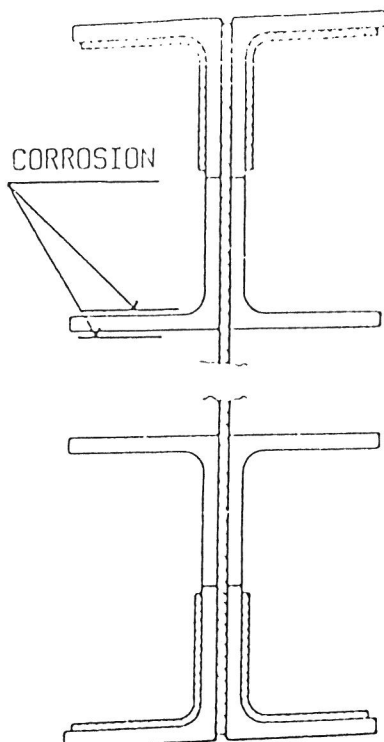
SECTION C-C

- b) Check of the main wing spar flange plates inside of the wing root part:
Drain off the fuel, remove fuel tanks and visually check surface of angles of upper and lower flange plates (see Section C-C). To enable the check, tear off the cloth blinding stops on the wing structure precluding access to the checked spots.
- c) Unless the corrosion presence is proved by checking, replace torn-off cloth blinding stops with the new ones and re-install fuel tanks.
Enter the result of check into the Aircraft Log-Book.
- d) If the main spar flange plate is attacked from corrosion, the wing must be put out of operation because its repair is impossible.
