## SERVICE LETTER No. L 131

**MODEL AFFECTED:** Z 242 L aircraft, S/N: 0837, 0838, 0839

**SUBJECT:** Corrective action to prevent hydraulic fluid leakage from the K 22-1200-7 brake.

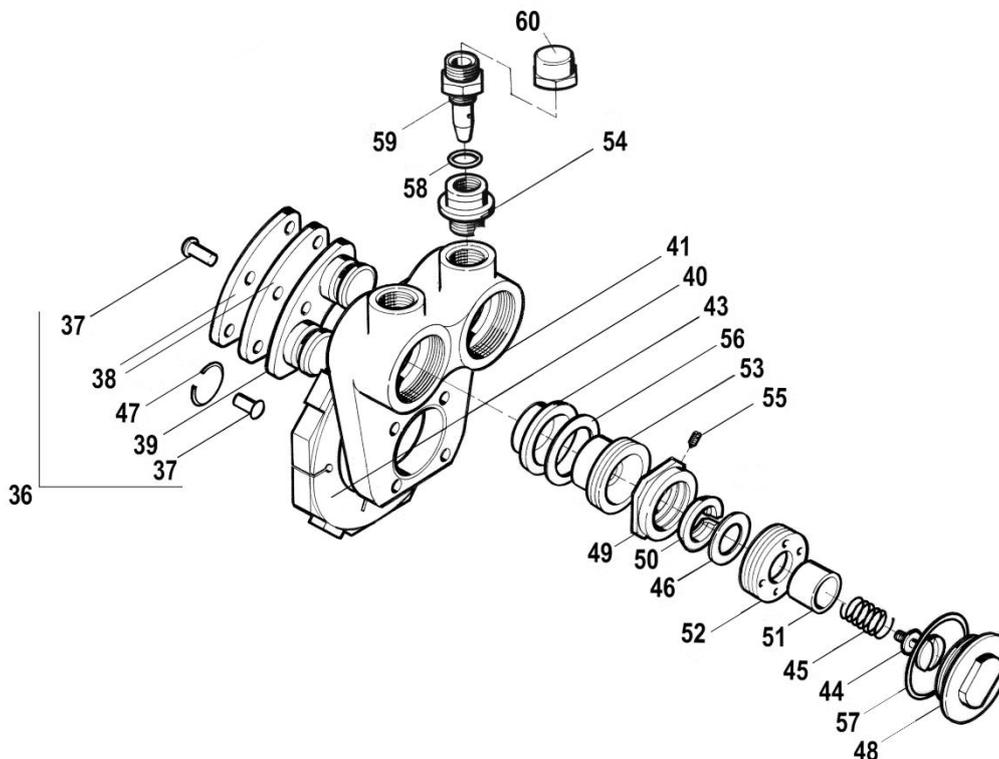
The leakage of hydraulic brake fluid can occur around the lid K22-0200.10 (item 48), as a solution of this cause, the manufacturer replaced the rubber O ring acc. to ČSN 02 9281.2 (item 57) with a dimension 48x2 with a more suitable "O" ring MS 28 775-135 with a dimension 48x2,5.

Fig. 1 The brake K22-1200-7 (positions numbers correspond to position numbers in IPC)

- a) Disconnect the brake from the aircraft hydraulic system (blind the outlet to the brake line). Loosen fixing screws and remove the brake from the landing gear axle,
- b) Remove the pistons (53) as follows (*performer only in case of brake leakage*):
  - loosen the lids (48) of working cylinder and push out the piston (53),
- c) Instead of the original rings (57) insert new „O“ rings (*delivered by the aircraft manufacturer*),
- d) Before reassembling the brake, wash carefully all parts with a suitable degreaser, dry them by compressed air and grease all functional parts with a suitable greaser.

Reassemble the brake by following the abovementioned steps in reverse order.
