SERVICE LETTER No. L 135

Z 242 L aircraft, S/N: 0852, 0853, 0854, 0855

Corrective action of the aircraft manufacturer to prevent damage

to the lower engine cover Drwg. No. Z242.6510-01.00

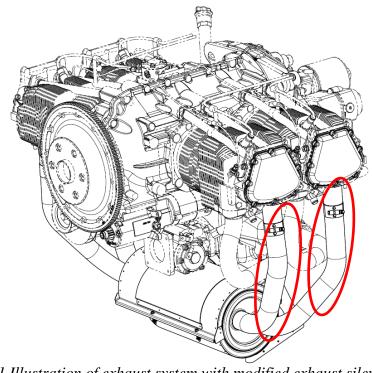
Based on operational experience, when the left exhaust tube is located close to the composite lower engine cover, the possibility of thermal influence of the lower engine cover through this tube is eliminated following corrective action.

Fig. 1 Illustration of exhaust system with modified exhaust silencer I

This corrective action consists in shortening the two tubes of the exhaust silencer Drwg. No. L242.6671-01.00G by 10 mm only on the left side of the exhaust at the point of division into the sleeve.

This increases the free space between the exhaust and the lower engine cover only on the left side.

The modified exhaust silencer has the designation Drwg. No. 990-527-00 and the total assembly of the modified exhaust silencer I is marked under Drwg. No. L242.6671E_UPR.
