SERVICE LETTER No. L 148-Rev.1

MAINTENANCE ALERT

MODELS AFFECTED: Z 242 L aircraft, S/N 0681, 0682, 0684, 0685, 0699, 0727, 0739,

SUBJECT: IN-SERVICE SAFETY EVENT REPORTING

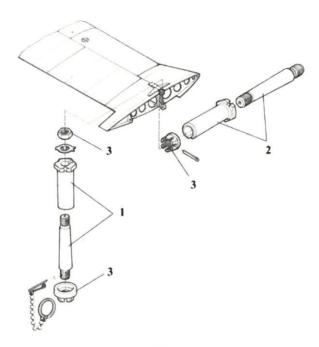
Fig. No. 1

PURPOSE: As a reaction to registering the fault of a pin of the main hinge of the

In case of removing the vertical pin, drawing number Z42.2181 ($\emptyset20$ h6), and/or horizontal pin, drawing number Z42.2191-00.00 ($\emptyset20$ h6) — see Picture 1) for any reason, it is necessary to always install completely new pins of the same dimension.

At reaching the lifetime limit of the pins, they need to be replaced by new pins immediately.

Re-use of the originally installed pins after their removal is forbidden and they always need to be taken out from operation, which must be properly documented.

Record a written report of the conducted inspection into the aircraft documentation. For tightening nuts M10 – see Picture 1, item 3, a torque wrench must be used at all times to meet the requirements of the prescribed tightening torque (23-27 Nm – see Maintenance Manual part 2, chapter 7.5).

Tightening of nuts without using the torque wrench is forbidden.
