**Service Letter No. L 111  
June 28, 2013**

**MODEL AFFECTED:            Z 50LS aircraft, S/N 0034**

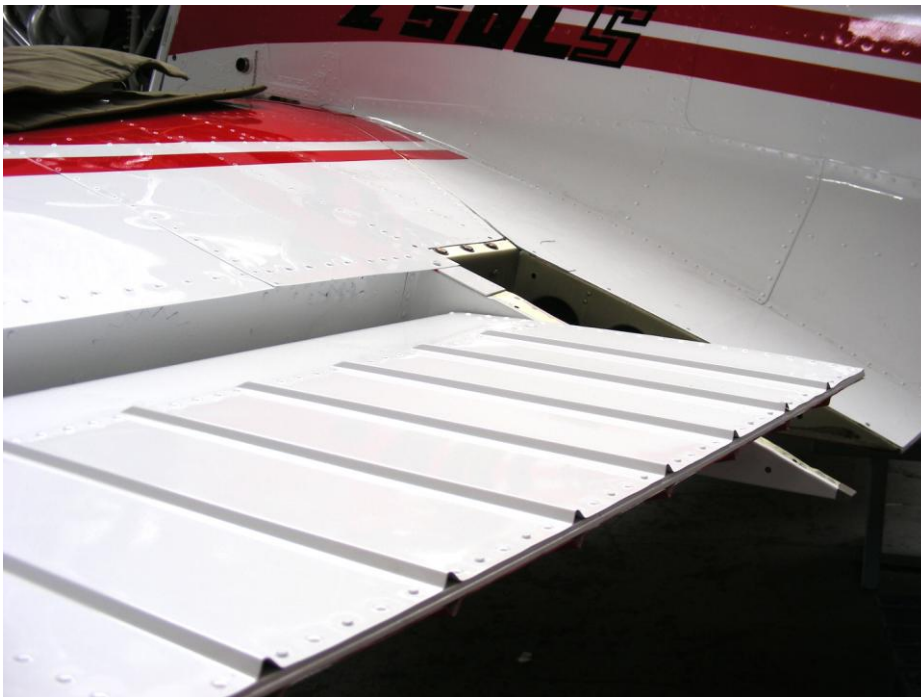
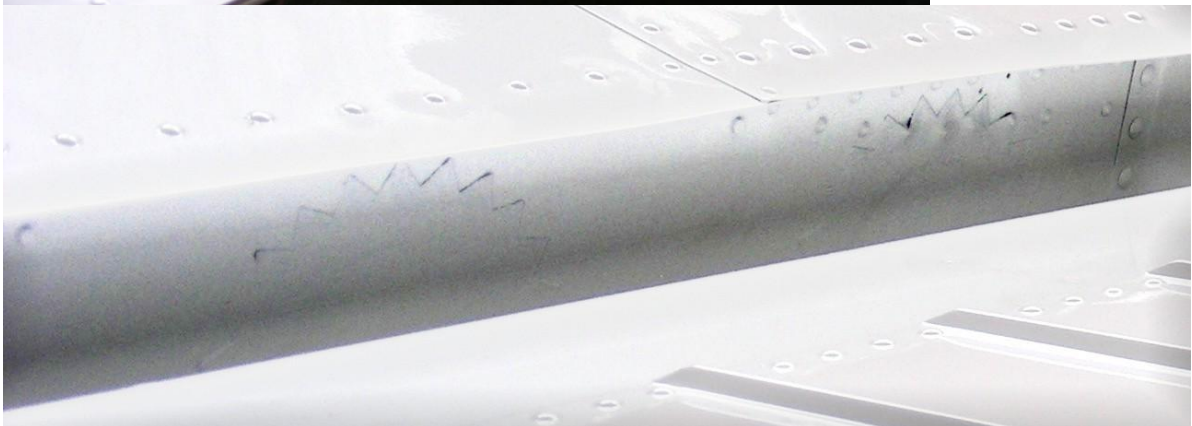
After the repair of the root part of rear wing spar in left-hand part of the wing where two cracks have been created during aircraft operation, it is necessary to check the repaired place and its surroundings, i.e. the root part of rear wing spar in left-hand part of the wing (see the pictures below) and also the root part of rear wing spar in right-hand part of the wing.

Perform visual check for cracks of root part of rear wing spar on both left-hand and right-hand wing parts from both upper and lower side of the wing after each 100 flight hours, i.e. during each 100-hour inspection.

The aileron shall be deflected to maximum position in required direction when checking root part of rear wing spar for cracks from upper and lower side of the wing.

Write a log of performed check and its results to the Aircraft Log Book.
