SERVICE LETTER No. L 126

MODEL AFFECTED: Z 242 L aircraft, S/N: 0836, TC-CEL

SUBJECT: Replacement of the polyamide screws on the ventilation window of the sliding canopy with a stainless steel screws.

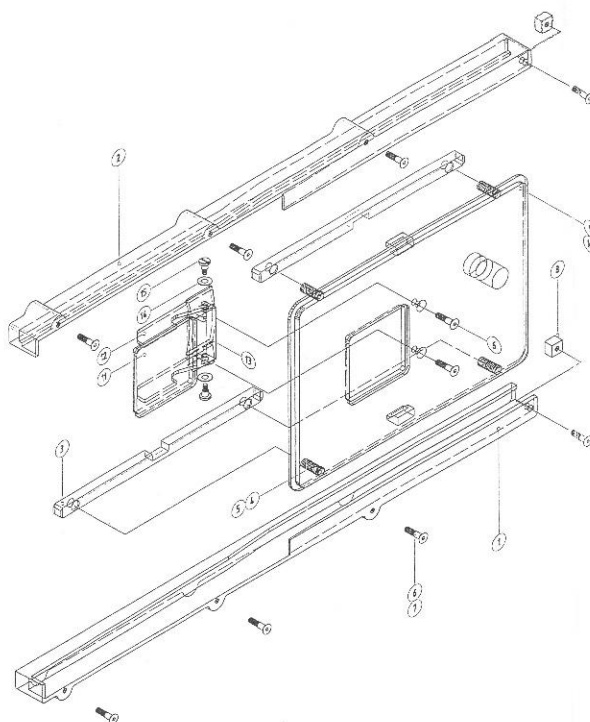
Perform the replacement all existing polyamide screw M3x10, DIN 963 (*code article 311000000638*) on the ventilation windows with a new stainless steel screws (*code article 466000121003*).

The screw replacement (item No. 6) perform according to the below mentioned Figure.

Select the appropriate torque moment so that the glass does not crack. Tighten the screws evenly.

CAUTION: When the tightening the screws use extreme caution!
