## SERVICE LETTER No. L 136-Rev.3

**MODEL AFFECTED:** Z 242 L aircraft, S/N: 0682, S/N 0685

**SUBJECT:** Aircraft manufacturer instructions for detected cracks and defects and repair instructions.

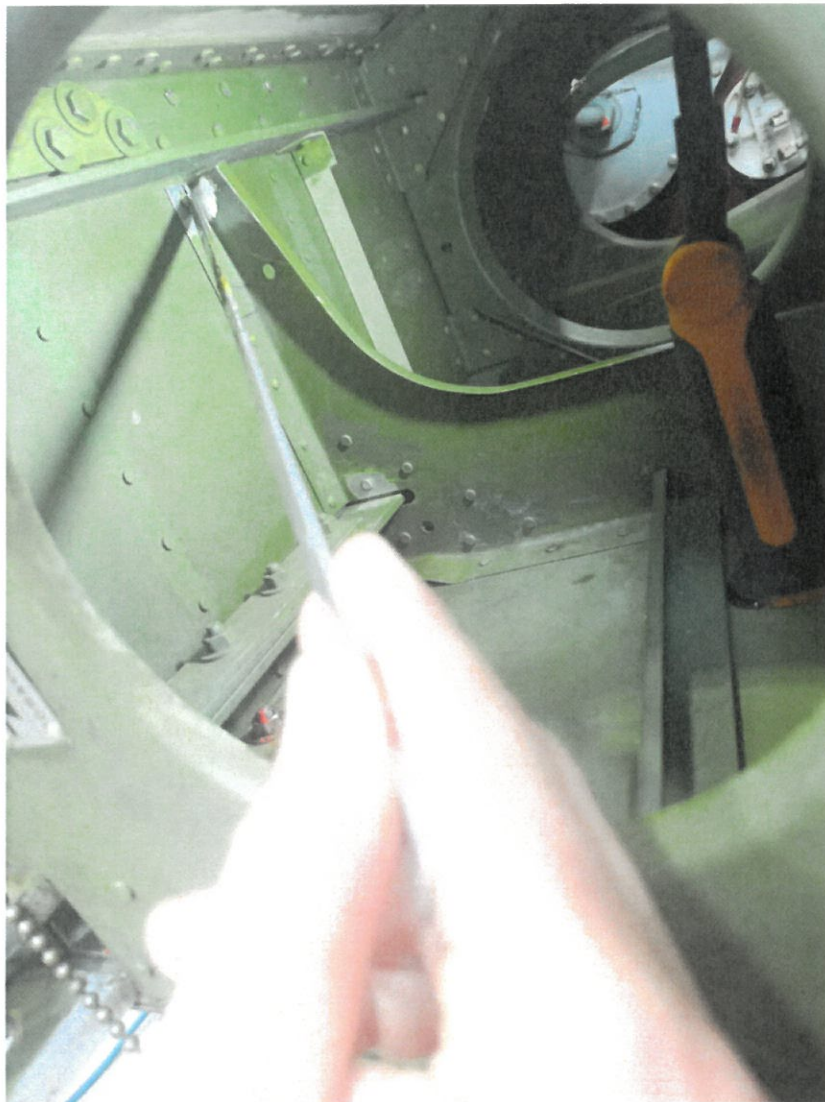
*Fig. No. 1 (S/N 0682)*

- 1) Second rib from both the left- and right-wing root. The length of the cracks is 4, resp. 2 mm (see Fig. 1 and 1A and No. 2).

1. Repair the rib cracks as described on pages 4-17 and 4-33 of the above-mentioned document. The final state of the repaired rib is as follows:

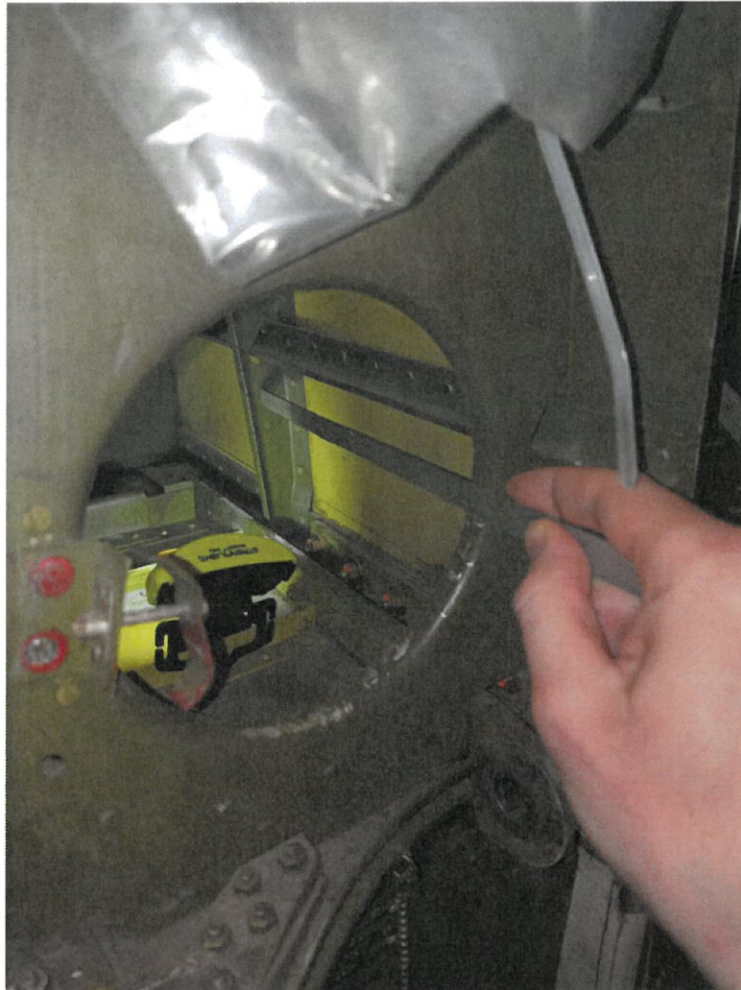
*Fig. No. 3 (S/N 0682)*

- 2) The rear part of the left root rib. The length of the crack is 3 mm (see Fig. No. 3 and No. 4.

- 2) Repair the rib cracks as described on pages 4-17, 4-30 and 4-37 of the above mentioned document. The final state of the repaired rib is as follows:

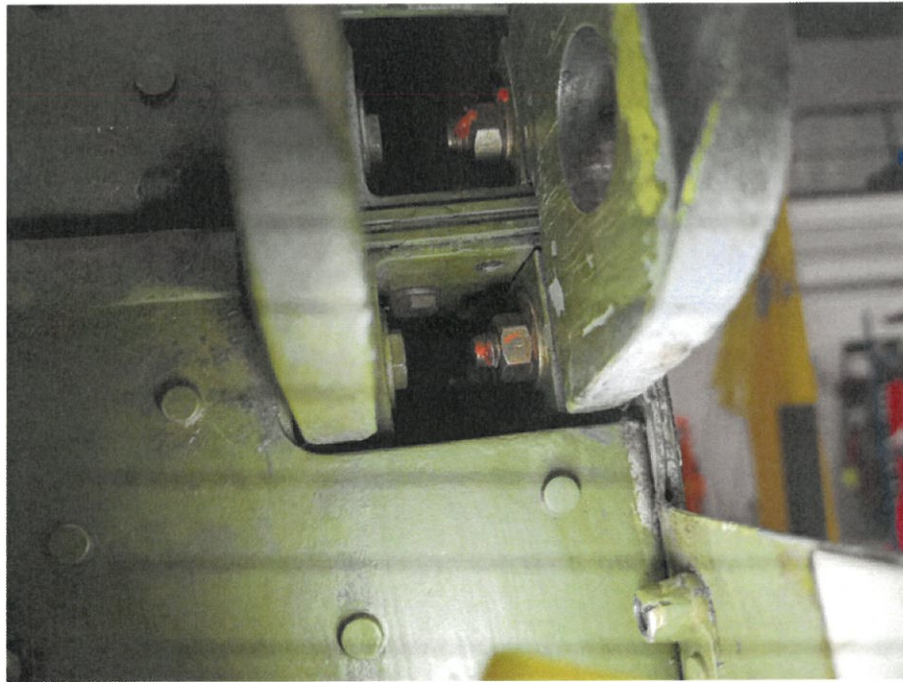
*Fig. No. 5 (S/N 0682)*

- 3) The sheared head of the technological rivet connecting the lower and upper plate of the main wing attachment point was found (see Fig. No. 5 and No. 6.).

- 3) Replace the sheared rivet by the bolt as described in Service Bulletin Z242L/20a issued by ZLIN AIRCRAFT a.s. on 6<sup>th</sup> June 1996.  
The rivet replacement for the screw must be performed on both wing attachments.
