SERVICE LETTER No. L 136-Rev.4

MODEL AFFECTED: Z 242 L aircraft, S/N: 0682, S/N 0685, S/N 0745

SUBJECT: Aircraft manufacturer instructions for detected cracks and defects and repair instructions.

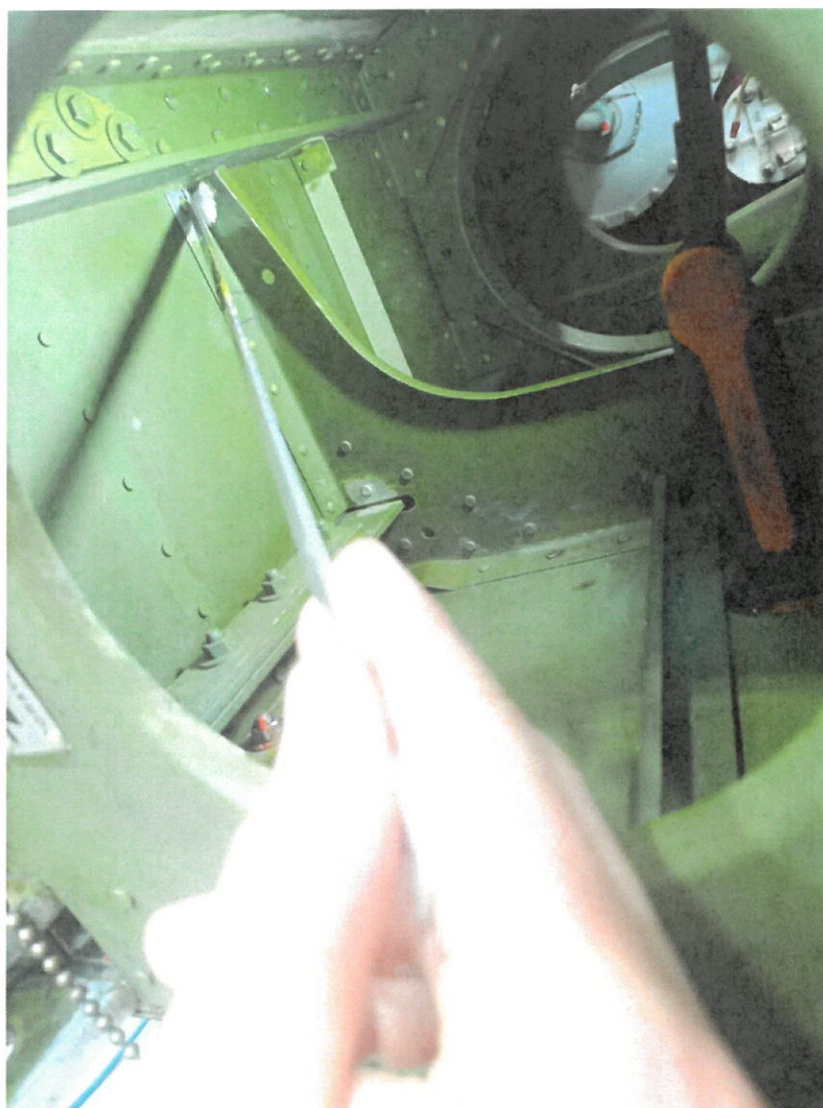
Fig. No. 1 (S/N 0682)

- 1) Second rib from both the left- and right-wing root. The length of the cracks is 4, resp. 2 mm (see Fig. 1 and 1A and No. 2).

1. Repair the rib cracks as described on pages 4-17 and 4-33 of the above-mentioned document. The final state of the repaired rib is as follows:

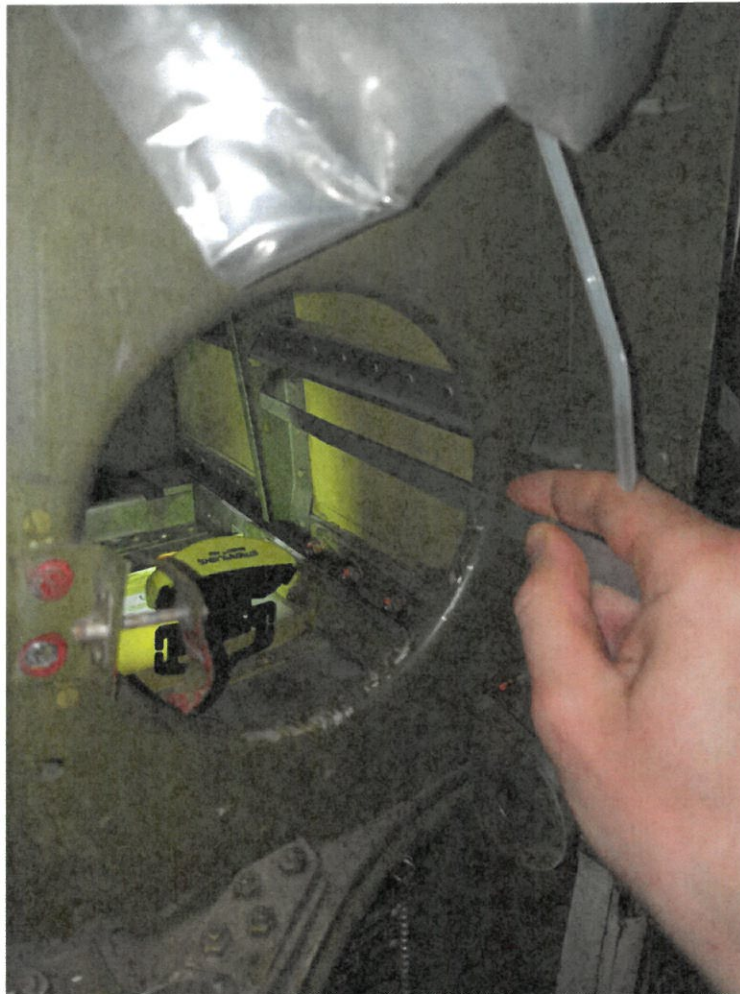
Fig. No. 3 (S/N 0682)

- 2) The rear part of the left root rib. The length of the crack is 3 mm (see Fig. No. 3 and No. 4.

- 2) Repair the rib cracks as described on pages 4-17, 4-30 and 4-37 of the above mentioned document. The final state of the repaired rib is as follows:

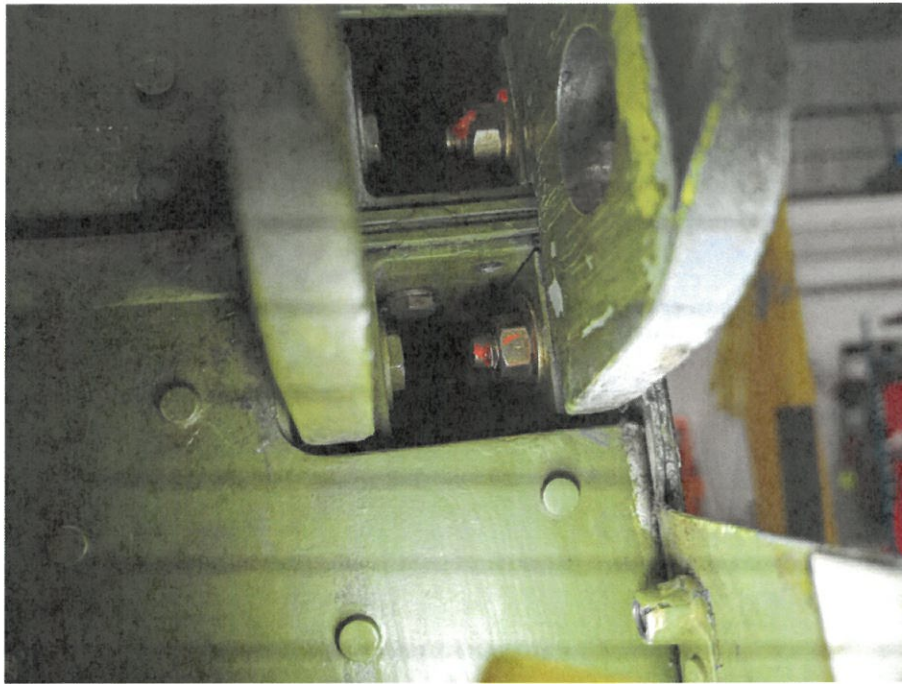
Fig. No. 5 (S/N 0682)

- 3) The sheared head of the technological rivet connecting the lower and upper plate of the main wing attachment point was found (see Fig. No. 5 and No. 6.).

- 3) Replace the sheared rivet by the bolt as described in Service Bulletin Z242L/20a issued by ZLIN AIRCRAFT a.s. on 6th June 1996.
The rivet replacement for the screw must be performed on both wing attachments.
