## SERVICE LETTER No. L 136

**MODEL AFFECTED:** Z 242 L aircraft, S/N: 0682

**SUBJECT:** Aircraft manufacturer instructions for detected cracks and defects and repair instructions.

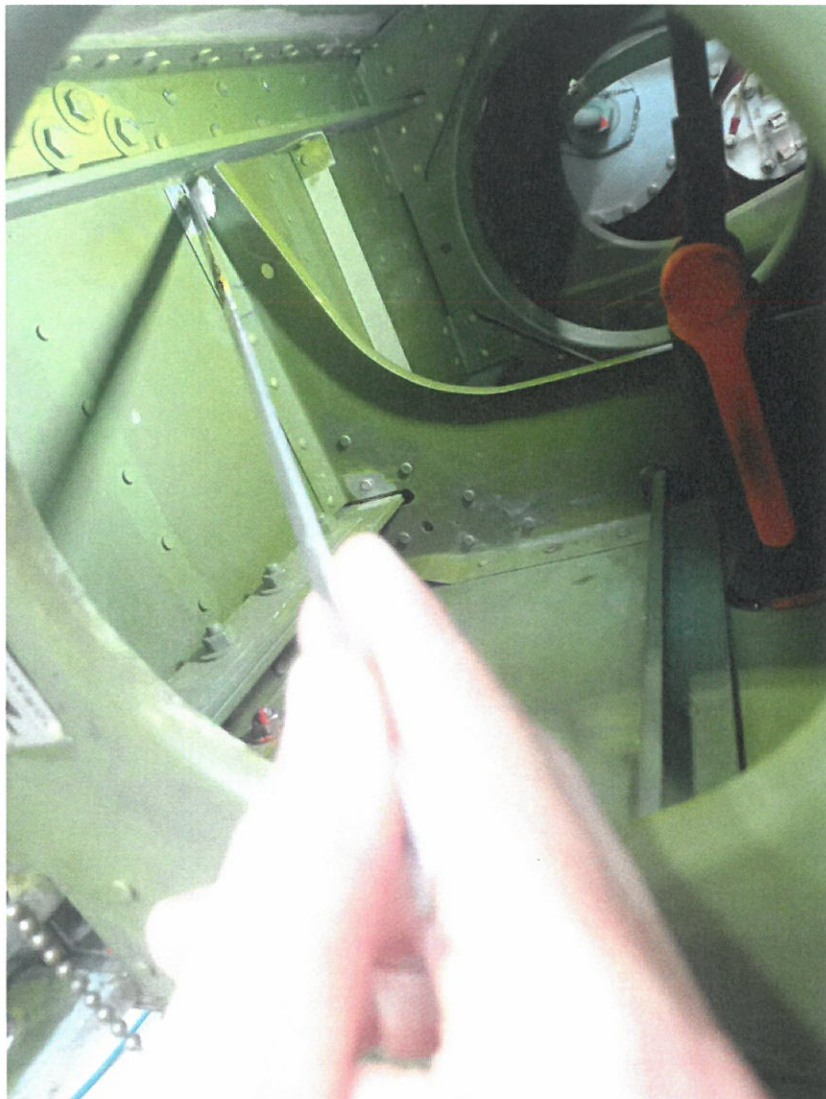
*Fig. No. 1*

- 1) Second rib from both the left- and right-wing root. The length of the cracks is 4, resp. 2 mm (see Fig. 1 and No. 2).

1. Repair the rib cracks as described on pages 4-17 and 4-33 of the above-mentioned document. The final state of the repaired rib is as follows:

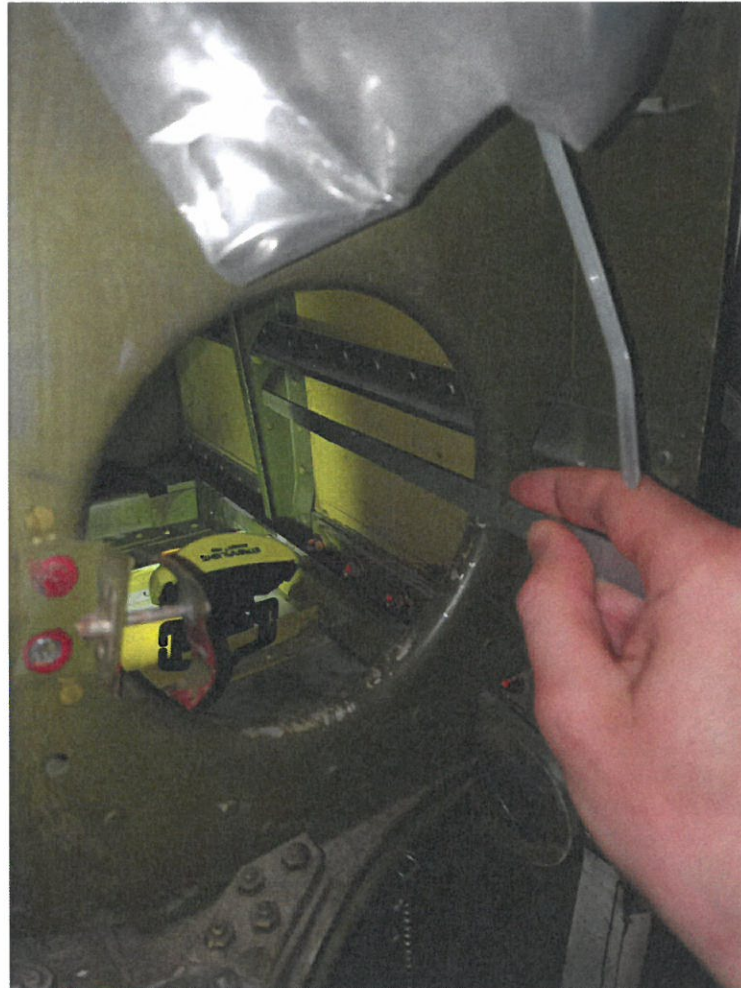
*Fig. No. 3*

- 2) The rear part of the left root rib. The length of the crack is 3 mm (see Fig. No. 3 and No. 4.

- 2) Repair the rib cracks as described on pages 4-17, 4-30 and 4-37 of the above mentioned document. The final state of the repaired rib is as follows:

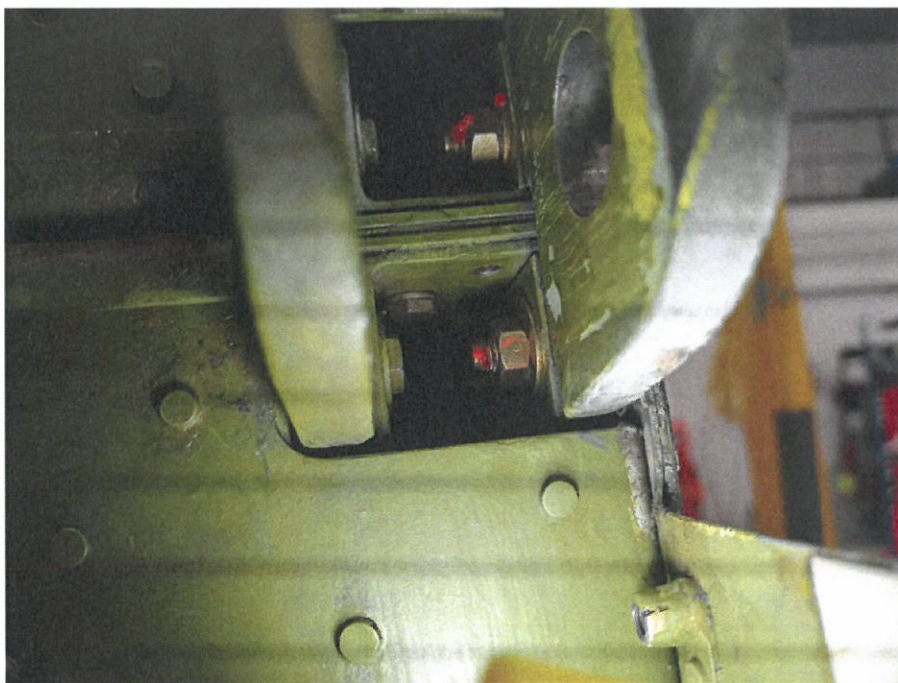
*Fig. No. 5*

- 3) The sheared head of the technological rivet connecting the lower and upper plate of the main wing attachment point was found (see Fig. No. 5 and No. 6.).

- 3) Replace the sheared rivet by the bolt as described in Service Bulletin Z242L/20a issued by ZLIN AIRCRAFT a.s. on 6<sup>th</sup> June 1996.  
The rivet replacement for the screw must be performed on both wing attachments.
