SERVICE LETTER No. L 138-Rev. 1

MODEL AFFECTED: Z 242 L aircraft, S/N: 0682

SUBJECT: Aircraft manufacturer instructions for detected cracks and defects and repair instructions.

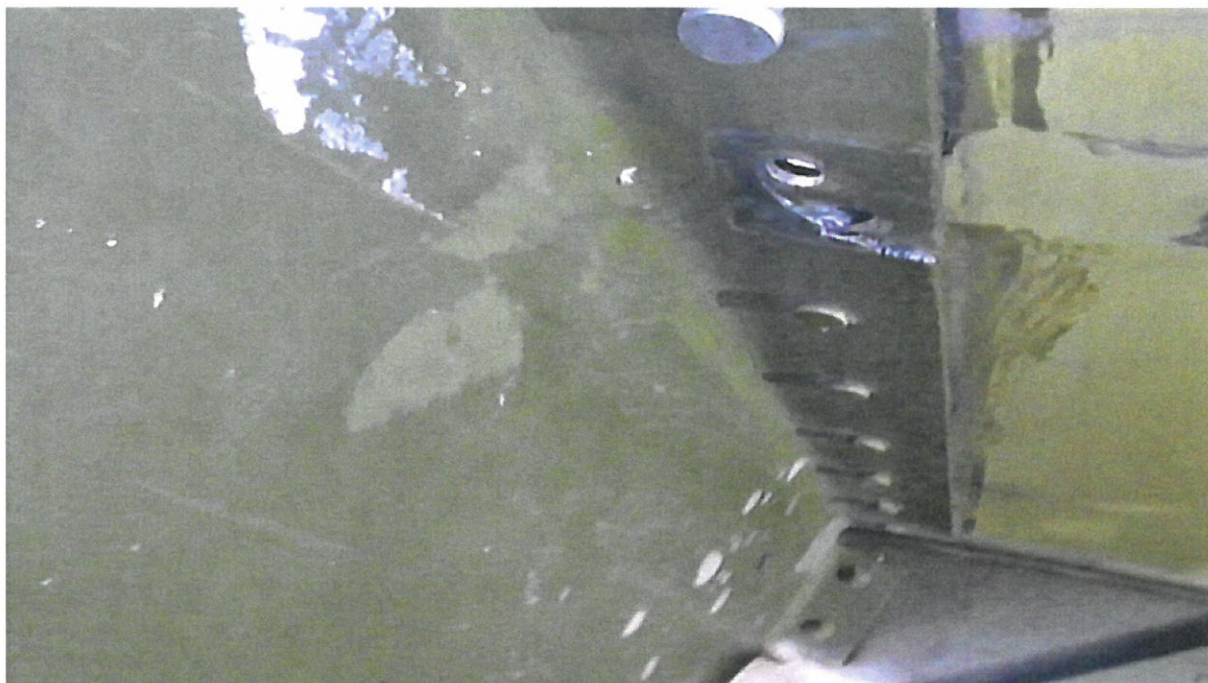
Fig. No. 1

- 1) Aft spar of the left wings (see Fig. 1 and No. 2 and No. 3).

- Repair the aft spar cracks as described on pages 4-43 of the above-mentioned document. The cracked rib will be strengthened by the plate in accordance with the sketch provided by the operator's maintenance facility (see Enclosure No. 1)
- The rivets used for reassembly and plate reinforcement will be provided by ZLIN AIRCRAFT. The rivets must be positioned in accordance with the enclosed sketch (Enclosure No. 1) – see annotations made by ZA.
- All existing rivet holes must be re-drilled for new rivet size to assure their proper alignment.
- New holes for rivets (ČSN 02 2302.5, size 2,6) will be drilled in accordance with the sketch provided by the maintenance facility and annotated by the manufacturer.
