## SERVICE LETTER No. L 138-Rev.4

**MODEL AFFECTED:** Z 242 L aircraft, S/N: 0682, S/N 0685, S/N 0745

**SUBJECT:** Aircraft manufacturer instructions for detected cracks and defects and repair instructions.

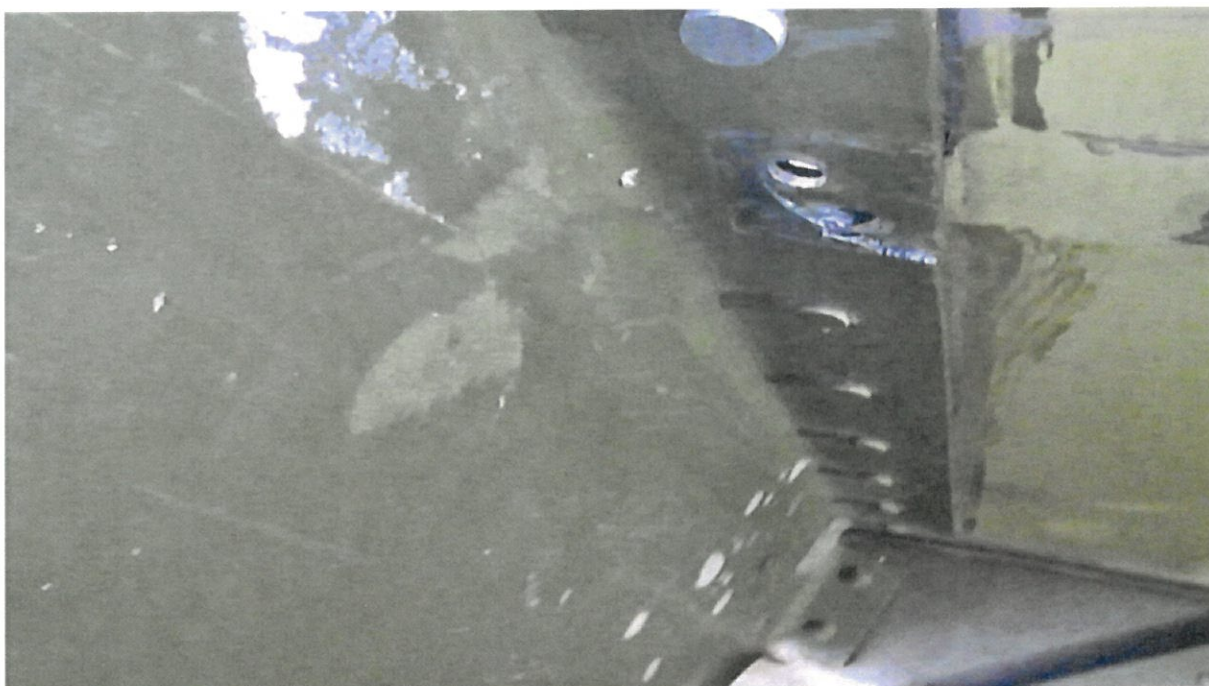
*Fig. No. 1 (S/N 0682)*

- 1) Aft spar of the left wings (see Fig. 1 and No. 2 and No. 3 and No. 4 and No. 5).

- Repair the aft spar cracks as described on pages 4-43 of the above-mentioned document. The cracked rib will be strengthened by the plate in accordance with the sketch provided by the operator's maintenance facility (see Enclosure No. 1)
- The rivets used for reassembly and plate reinforcement will be provided by ZLIN AIRCRAFT. The rivets must be positioned in accordance with the enclosed sketch (Enclosure No. 1) – see annotations made by ZA.
- All existing rivet holes must be re-drilled for new rivet size to assure their proper alignment.
