SERVICE LETTER No. L 138

MODEL AFFECTED: Z 242 L aircraft, S/N: 0682

SUBJECT: Aircraft manufacturer instructions for detected cracks and defects and repair instructions.

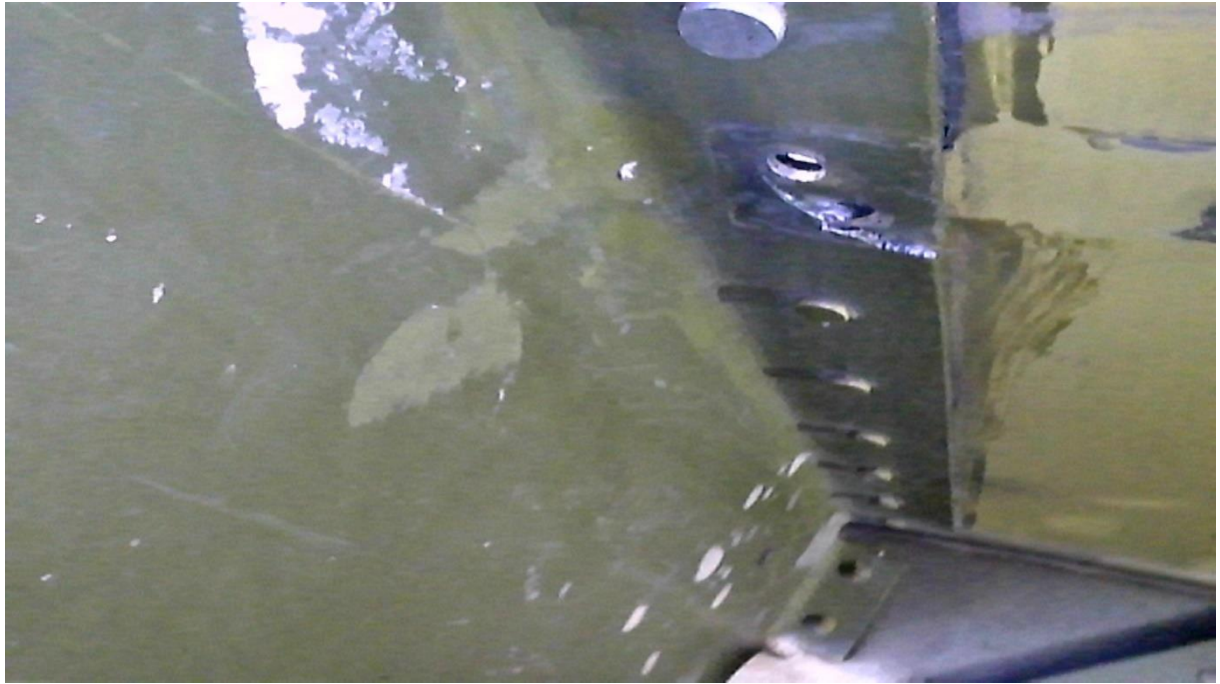
Fig. No. 1

- 1) Aft spar of the left wings (see Fig. 1 and No. 2 and No. 3).

- Repair the aft spar cracks as described on pages 4-43 of the above-mentioned document. The cracked rib will be strengthened by the plate in accordance with the sketch provided by the operator's maintenance facility (see Enclosure No. 1)
- The rivets used for reassembly and plate reinforcement will be provided by ZLIN AIRCRAFT. The rivets must be positioned in accordance with the enclosed sketch (Enclosure No. 1) – see annotations made by ZA.
- All existing rivet holes must be re-drilled for new rivet size to assure their proper alignment.
- New holes for rivets (ČSN 02 2302.5, size 2,6) will be drilled in accordance with the sketch provided by the maintenance facility and annotated by the manufacturer.
