## SERVICE LETTER No. L 139

**MODEL AFFECTED:** Z 242 L aircraft, S/N: 0787

**SUBJECT:** Aircraft manufacturer instructions for detected cracks and repair instructions.

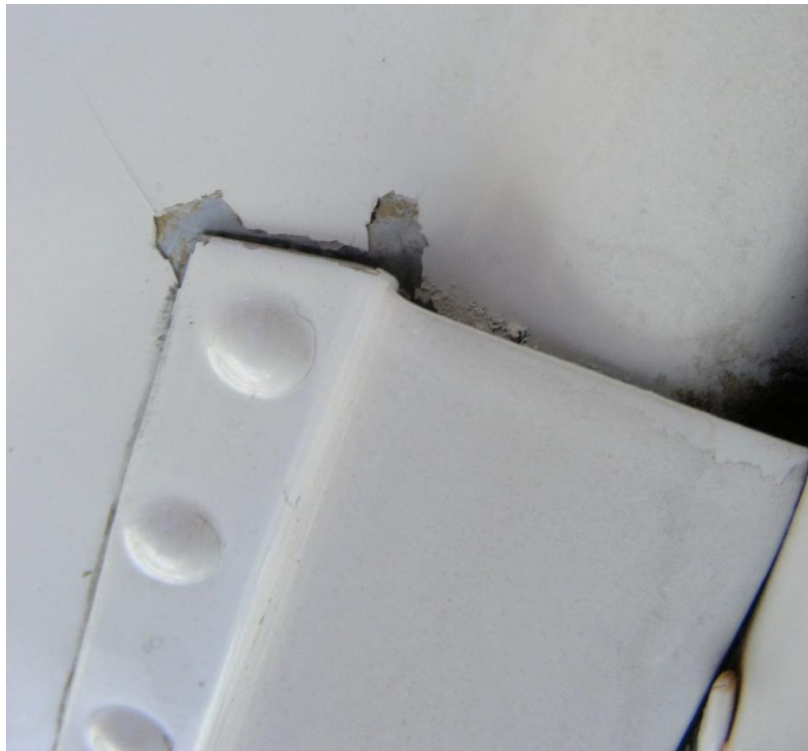
*Fig. No. 1*

Within the aircraft acceptance after 1500 flight hours inspection the operator reported the cracks disclosed on the lower skin of the elevator. *See Figures No. 1 and No. 2 and No. 3.*

The reported findings were considered by the Commission of Airworthiness and Reliability of ZLIN AIRCRAFT a.s. and its conclusion is that the cracks are repairable with no impact on airplane's airworthiness:

- Remove the existing cover of the trim rod (drawing number L242.3610-08.04A). Drill the hole of 1,5 mm in diameter at the end of each crack in order to stop its propagation. Ream the drilled holes.
- Instead of the removed existing cover install the modified one (drawing number 999-038) which is intended as a repair patch as well. The modified cover is longer by 30 mm compared to the original one. During the installation set the highest point of the cover at the same distance from the trim tab as the original one in order to cover the cracks **and secure free movements of the trim rods.**
- Use the CHERRYMAX CR4523 rivets size 1/8"x 0.260 (approx. 3,2x6 mm) delivered by Zlin Aircraft.
- Note this repair into the Aircraft Log Book.
