SERVICE LETTER No. L 140

MODEL AFFECTED: Z 242 L aircraft, S/N: 0852, 0853, 0854, 0855

SUBJECT: Modification of fuel tank venting.

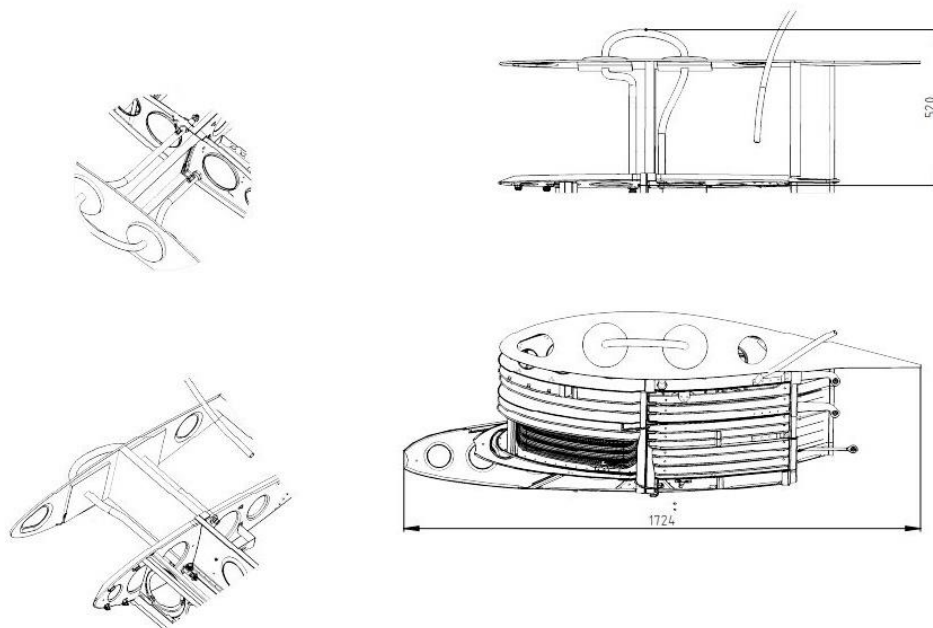
Fig. No. 1: Drawing of fuel tank venting assembly

Aircraft manufacturer ZLIN AIRCRAFT a.s. made following modification of fuel tank venting:

Parts Fuel intake throat (*Drwg. No. L242.7232*) and Vent throat (*Drwg. No. L242.7233*) were connected using Hose (*Drwg. No. 990-528-00.02*).

Hose is routed through two holes by Hose guides (*Drwg. No. 990-528-00.01*) in middle of winglet's rib (*Drwg. No. Z242.2160-00.04*).

Hose is connected to fuel throats using clamp 5 ČSN 02 2752.04 and Strip 5 ČSN 02 2757.

PROCEDURES: Disassemble winglet (*Drwg. No. Z242.2160*).
Grease both ends of Hose (*Drwg. No. 990-528-00.02*) by vaseline.
Fix one end of Hose to Fuel intake throat (*Drwg. No. L242.7232*) by clamp 5 ČSN 02 2752.04 and Strip 5 ČSN 02 2757).
Stick Hose through one Hose guide (*Drwg. No. 990-528-00.01*) and insert Hose guide into winglet's rib (*Drwg. No. Z242.2160-00.04*) on corresponding side.
Pull the other end of Hose out of winglet's rib. Apply Hose guide on Hose and insert it into winglet's rib on the other side.
Fix second end of Hose to Vent throat (*Drwg. No. L242.7233*) by Clamp 5 and Strip 5.
Tighten both clamps 5 and reassemble winglet.
