SERVICE LETTER No. L 144-Rev.2

MODEL AFFECTED: Z 242 L aircraft, S/N: 0685

SUBJECT: Aircraft manufacturer instructions for detected cracks and defects and repair instructions.

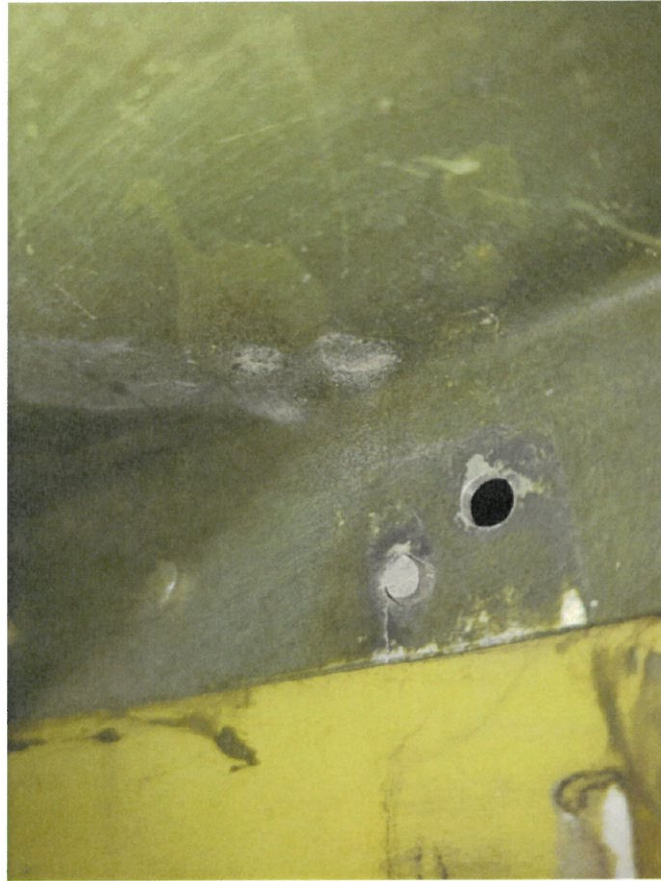
Fig. No. 1

- 1) The rear part of the left root rib (see Fig. 1 and No. 2) The length of the crack is 3mm.

PROCEDURES: For corrective actions recommended by the manufacturer follow the repair procedures recommended by the FAA document AC-43.13-1B, issued on 8 SEP 98 as follows:

Repair the rib cracks as described on pages 4-17, 4-30 and 4-37 of the above-mentioned document. The final state of the repaired rib as follows:
