## SERVICE LETTER No. L 148

### MAINTENANCE ALERT

- DATE:** April 30, 2024
- TO:** All operators of ZLIN airplanes
- MODELS AFFECTED:** All Z 242 L aircraft
- SUBJECT:** IN-SERVICE SAFETY EVENT REPORTING
- TIME OF COMPLIANCE:** Immediately after receipt of this letter

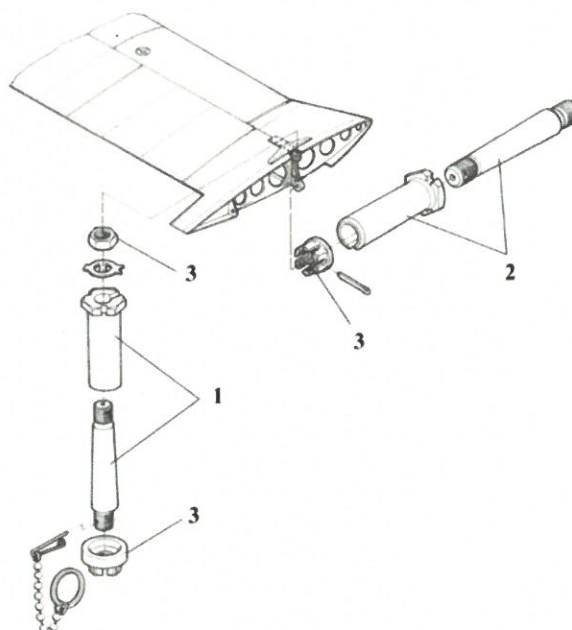
Fig. No. 1

- PURPOSE:** As a reaction to registering the fault of a pin of the main hinge of the wing, the manufacturer of aircraft, ZLIN AERO a.s., prescribes a number of immediate measures to all operators as a part of immediate reaction and demands immediate execution of the following actions in order to secure the safety of flight operations of the aircraft:

For tightening nuts M10 – see Picture 1, item 3, a torque wrench must be used at all times to meet the requirements of the prescribed tightening torque (23-27 Nm – see Maintenance Manual part 2, chapter 7.5).

**Tightening of nuts without using the torque wrench is forbidden.**

Always use only tools prescribed by the manufacturer for pin removal (drawer L242.9510-00.00).

**It is forbidden to use tools not approved by the manufacturer for pin removal.**
