SERVICE LETTER No. L 117

MODELS AFFECTED: **Z 242 L aircraft, S/N 0742**

SUBJECT: **Operation limits – Increase of safe life limit to 18 000 flight hours**

Z 242L Assessment Report - Aircraft Safe-life prolongation up to 18 000 flight hours Sault College Aviation Technology

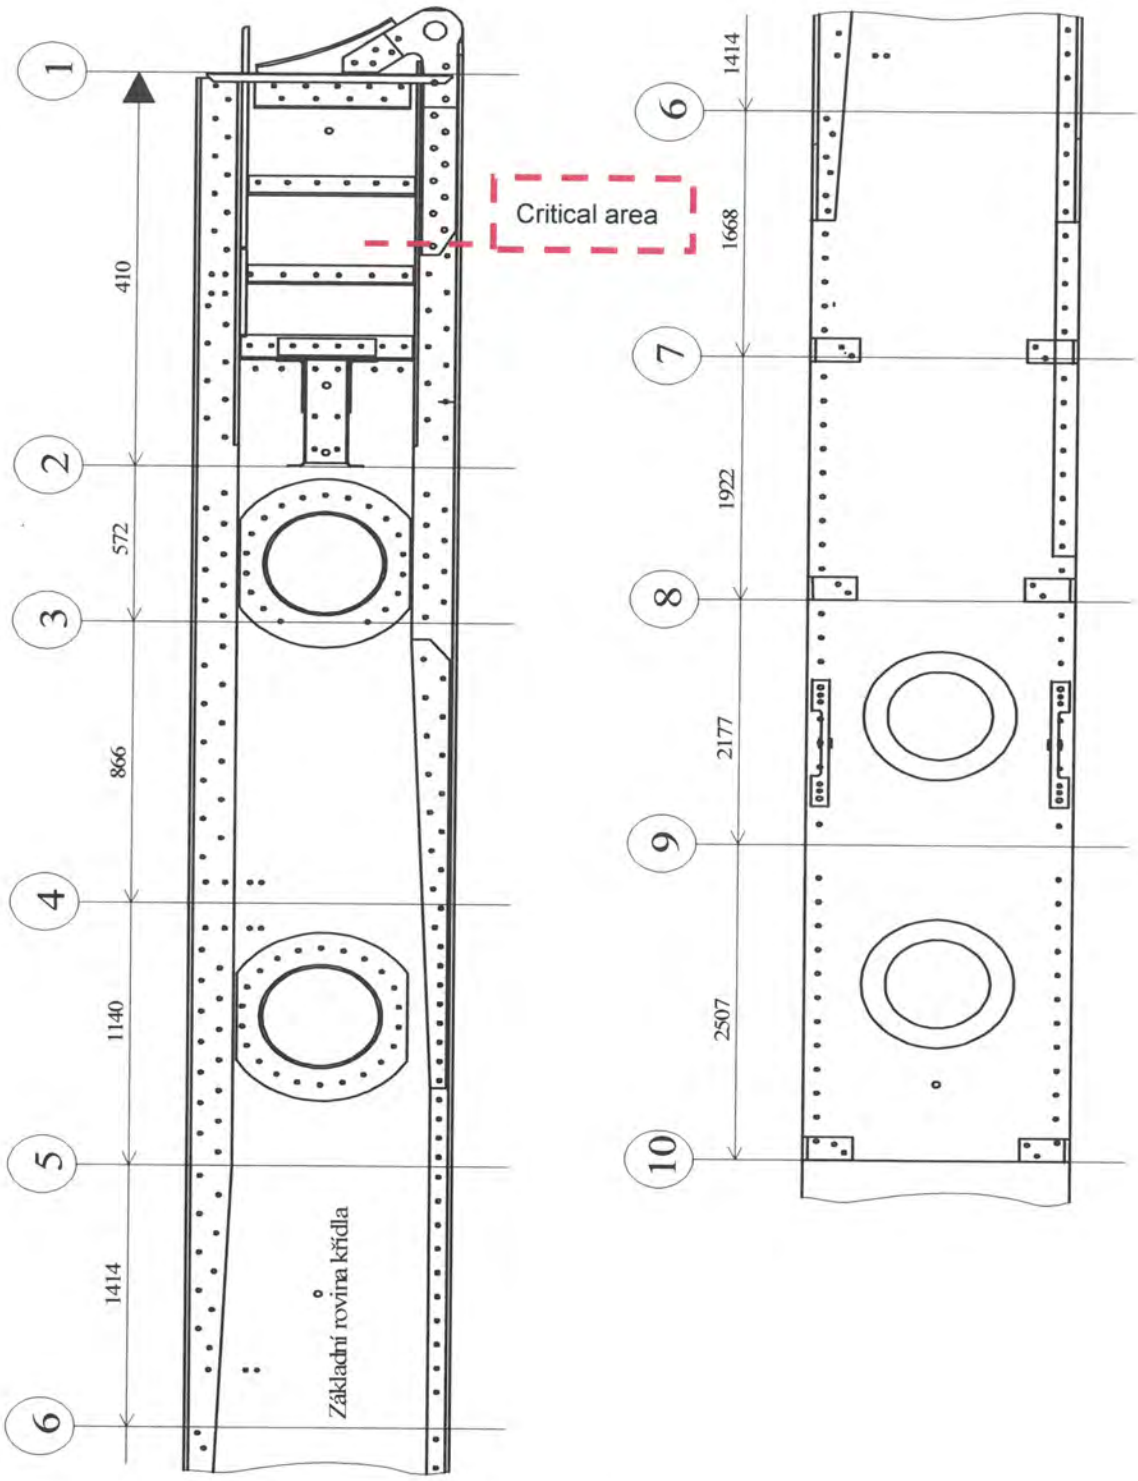
Fig. 4-2 Main wing spar of the Z 242L aircraft

The critical point of wings, drawing No. L242.2100/2200 of Z 242L aircraft from the fatigue life point of view is lower duralumin flange close behind the attachment fittings.

4.1 Stress values in critical section A-A (Category U)

Loading in flight:	n= 1.0 g	**σ_{+1g} = 24.90 MPa**	/flange margin/
Loading at the ground stay:	n= -1.0 g	**σ_{-1g} = -7.4 MPa**	/flange margin/

$$L_B = L_S^{(Category\ U)} / j_N = 99\ 737 / 5 = 19\ 947 \text{ flight hours.}$$
$$L_B = L_S^{(Category\ N)} / j_N = 127\ 261 / 5 = 25\ 452 \text{ flight hours.}$$

LB= 18 000 flight hours.

Conic pins and bushings for attaching the wings to the fuselage - after every 6000 flight hours.

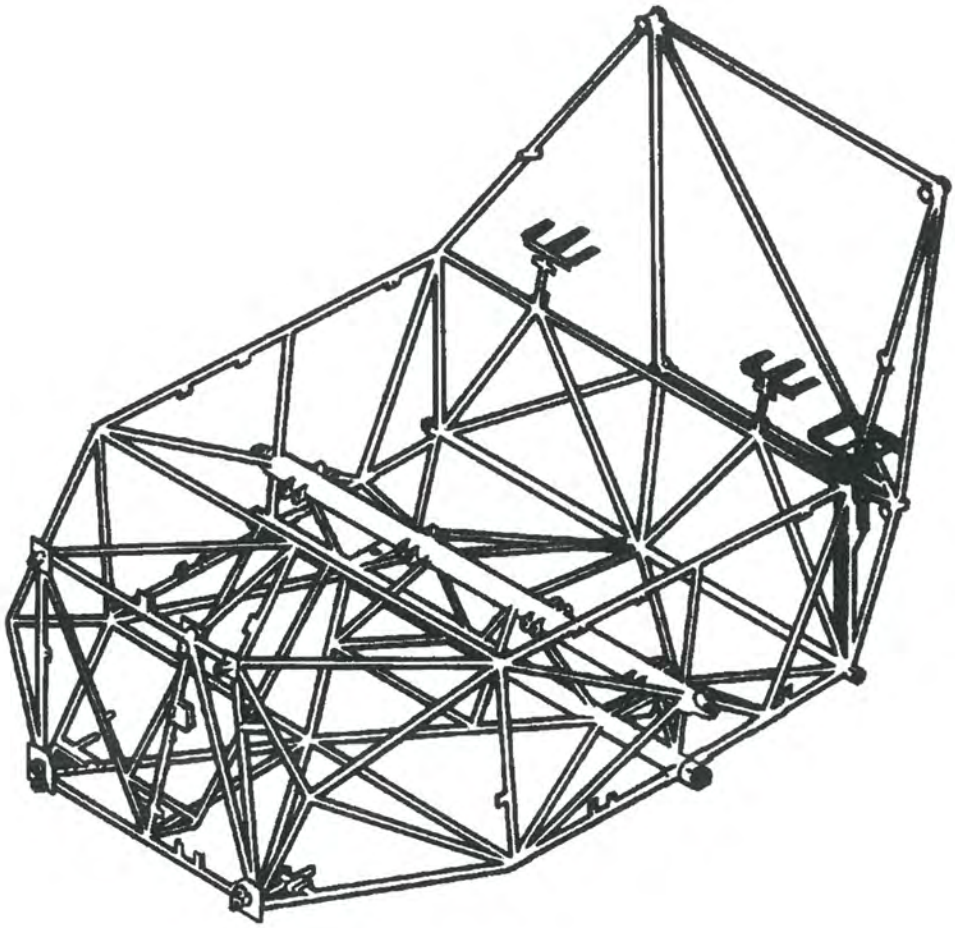
Fig. 5-1 Fuselage frame of the Z 242L aircraft

The main spar of the fuselage frame is a complicated weldment that is made of steel tubes from L-CM3 material according to valid regulations and procedures. There are installed upper and lower attachments of the wing, attachments of the front seats and attachments of the main landing gear on the main spar of the fuselage frame. The lower flange of the main spar is equipped with pressure probe which signalises to the pilot contingent appearance of a crack on the flange.

Loading in flight: n= +1 g **σ_{+1g} = 57.9 MPa**
Loading at the ground stay: n= -1 g **σ_{-1g} = -2.2 MPa**

$L_B = L_S^{(Category\ U)} / j_N$ = 461 180 / 8.0 = 57 647 flight hours.
$L_B = L_S^{(Category\ N)} / j_N$ = 482 507 / 8.0 = 60 313 flight hours.

LB= 18 000 flight hours.

- Lower flange pressure following-up - every 500 flight hours or once a year.

- Lower flange pressure following-up - after every 6000 flight hours.

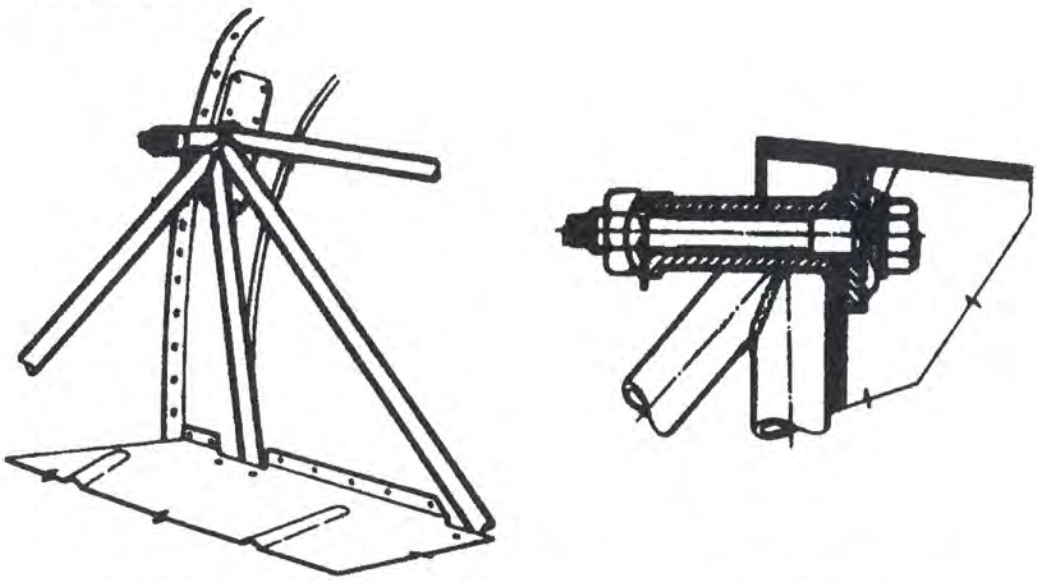
Fig. 6-1 Connection of fuselage front and rear part of the Z 242L aircraft

We appoint the value of Safe Fatigue Life of bolts connecting central and rear part of the fuselage, with respect to present maintenance system to:

LB= 6 000 flight hours.

Replacement of the bolts connecting central and rear part of the fuselage:
- after every 6000 flight hours.

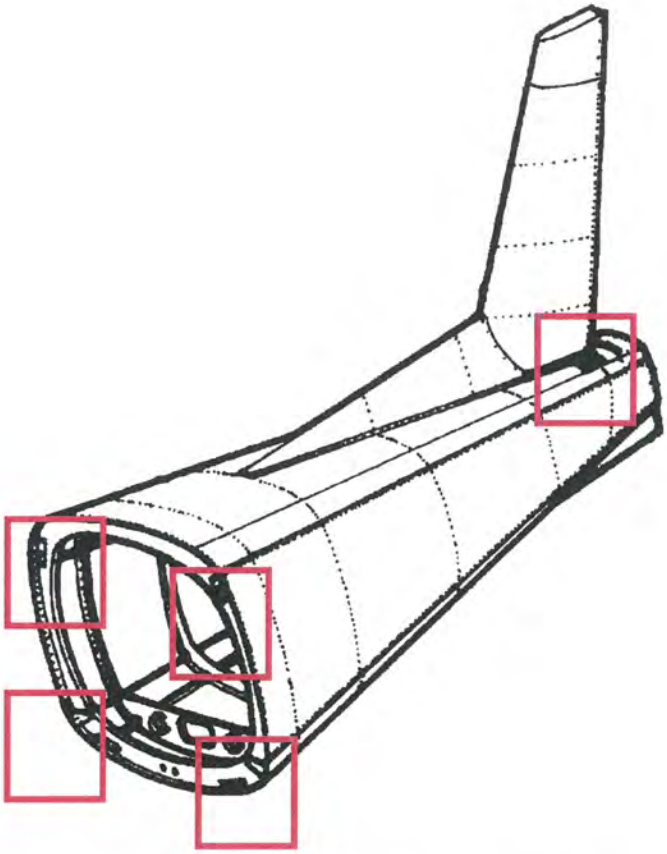
Fig. 6-2 Fuselage rear part of the Z 242L aircraft with market areas for visual inspection check

The Safe Fatigue Life of rear part of the fuselage will be secured with regular inspections and repairs in operation in accordance with specified maintenance system.

LB= 18 000 flight hours.

Visual inspection checks for crack, damage, deformation; see Fig. 6-2
- after every 500 flight hours.

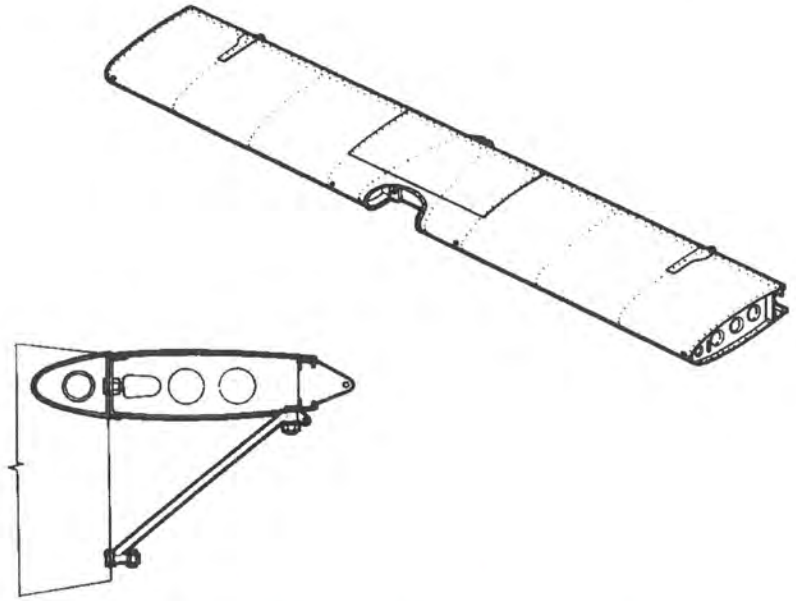
Fig. 7- 1 Stabilizer including supports

Safe Fatigue Life of tail surfaces was specified neither by calculation, nor by test. Safe Fatigue Life of tail units will be secured by regular checks and contingent repairs in operation in accordance with specified maintenance system.

LB= 18 000 flight hours.

- Stabilizer supports replacement including connecting bolts - after every 6000 flight hours.
- Connecting bolts attachment fittings of the stabilizer - after every 6000 flight hours.

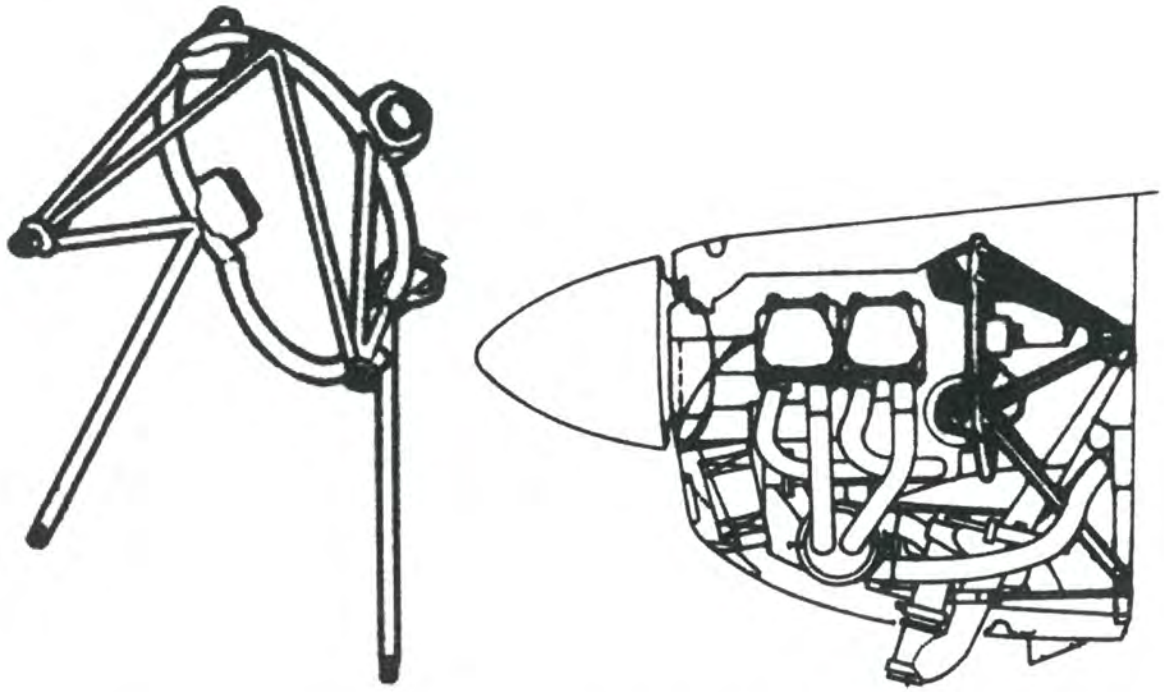
Fig. 8-1 Engine mount including engine clamping is shown on the

Safe Fatigue Life of engine mount was specified neither by calculation, nor by test. Safe Fatigue Life of engine mount will be secured by regular checks and repairs in operation in accordance with specified maintenance system.

LB= 6 000 flight hours.

Proposed regular checks according to:	Maintenance Manual for aircraft Z 242L - Part I, II.
Replacement:	
• Engine mount	- after every 6000 flight hours.
